COLLINS COMPANY UPPER DAM CT 00674

PHASE I INSPECTION REPORT NATIONAL DAM INSPECTION PROGRAM

DEPARTMENT OF THE ARMY
NEW ENGLAND DIVISION, CORPS OF ENGINEERS
WALTHAM, MASS. 02154

JULY, 1979

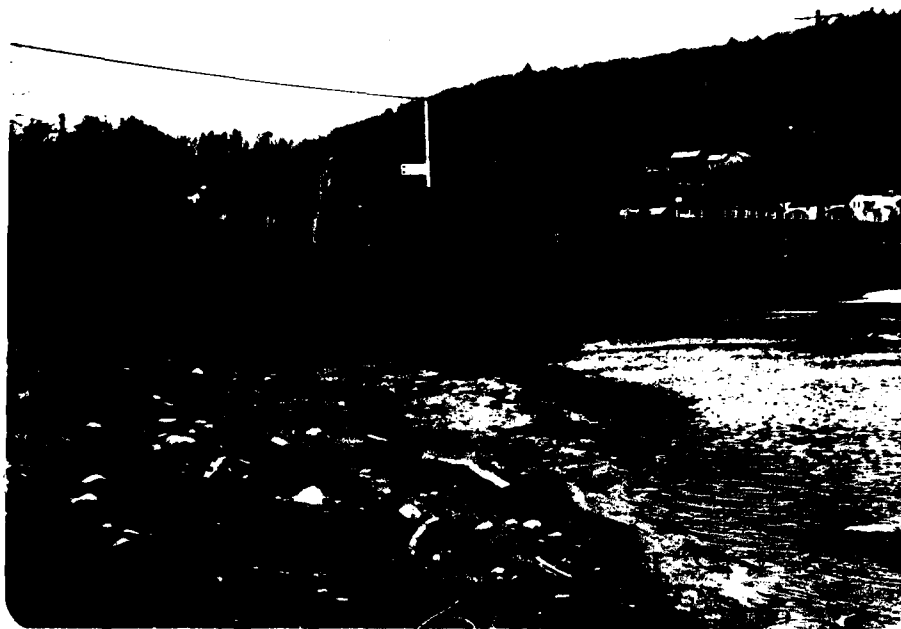
PHOTO 3 - Upstream view of earthen embankment and eight sluice gates at left end of main dam (April, 1979).

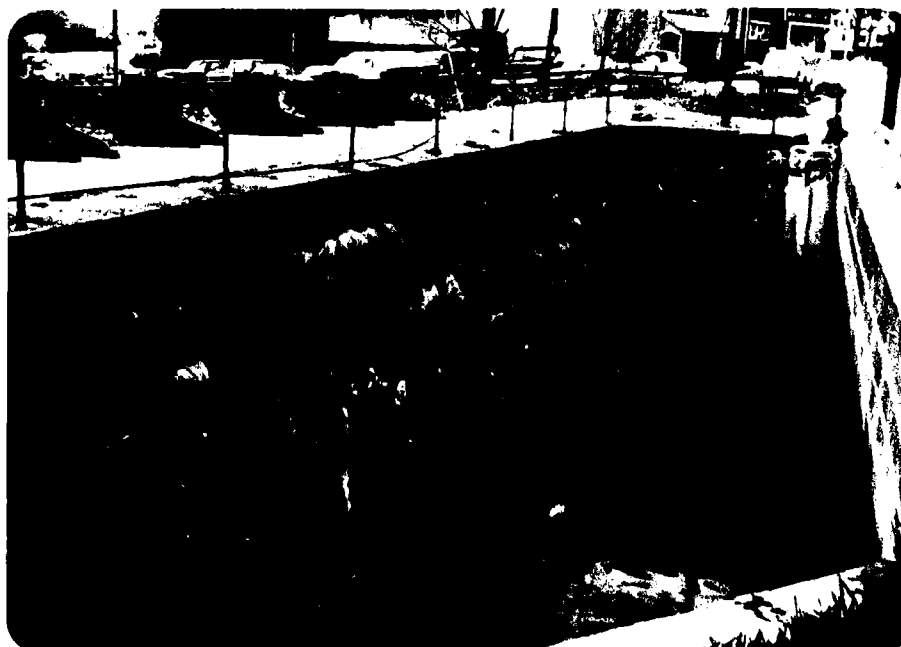
PHOTO 4 - Downstream masonry headwall for sluice gates at inlet to forebay (April, 1979).

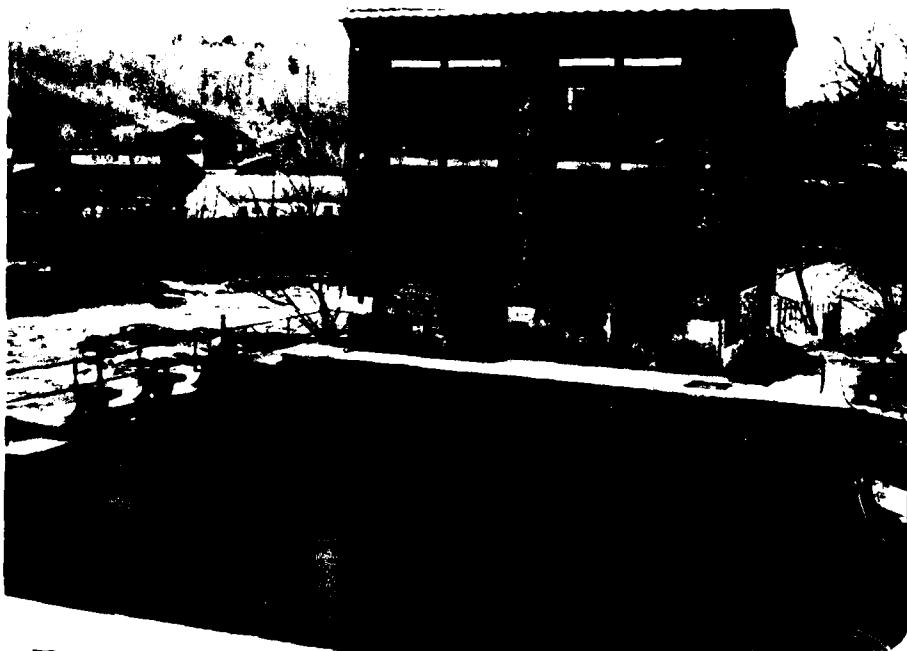
4. The valve stem to the left low level outlet in the wing dam abutment is disconnected, rendering it inoperable.
5. The birch tree growing from the upstream masonry retaining wall of the earthen embankment could eventually cause displacement of some of the masonry.

PHOTO 6 - Low level gate valves and trash racks at turbine intake.
Note disconnected stem of left gate valve and corrosion
of trash racks (April, 1979).

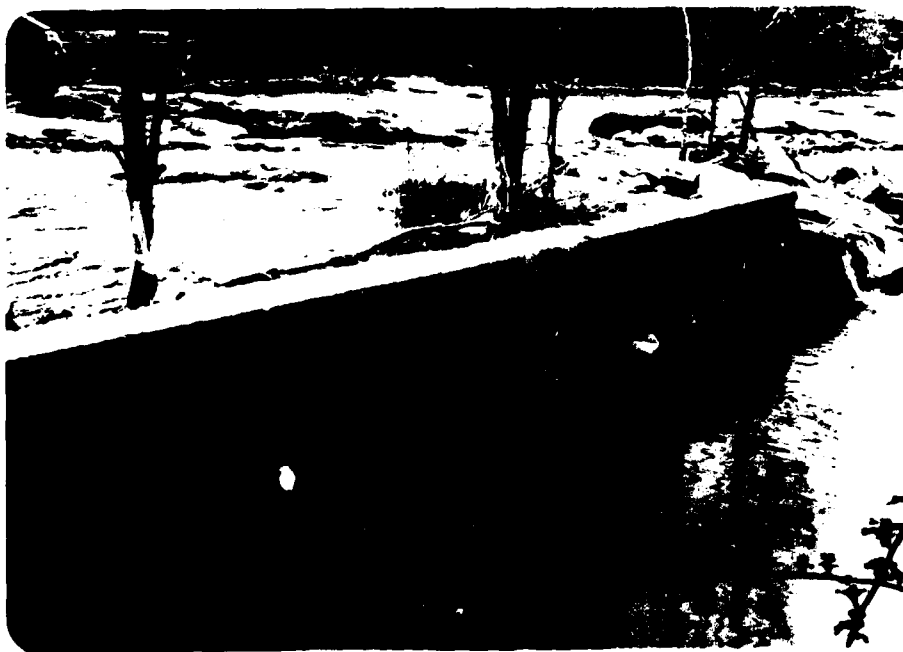
Discharge from the powerhouse is into a tailrace channel bounded on the left by a low concrete training wall (Photo 10) and on the right by a dry laid stone retaining wall and riverbank. The training wall is in poor condition, exhibiting cracking and undermining. Approximately 15 feet from the downstream end, a deteriorated portion of the wall allows water from the main channel to flow into the tailrace. The right retaining wall is in fair condition with minor seeps about 15 and 25 feet downstream of the powerhouse. Erosion is occurring at a footpath where the stone retaining wall meets the concrete substructure of the powerhouse (Photo 9).

PHOTO 10 - Concrete tailrace training wall. Note cracking and deterioration of concrete (April, 1979).

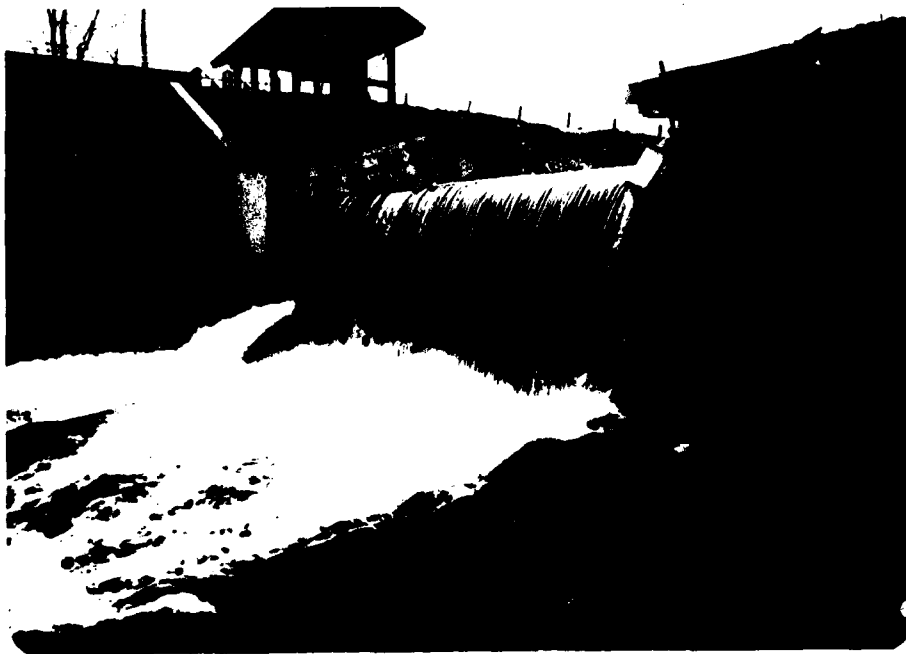
PHOTO 14 - Close-up of downstream face of forebay dam. Note broken flashboards, and natural ground downstream of right abutment and under Route 179 bridge (April, 1979).
